**Flood Control Project Maintenance
Levee Inspections**

Maintenance Issue Types Only, Levee Inspection Report By Mile - Spring 2019

Reclamation District No. 2104 Peters Pocket Tract

Waterway	Bank	Unit Miles	Inspection Start/End	Inspector
Unit No. 01 Cache Slough/Unit No. 02 Haas Slough	Left	6.85	05/15/2019 05/15/2019	David Julian

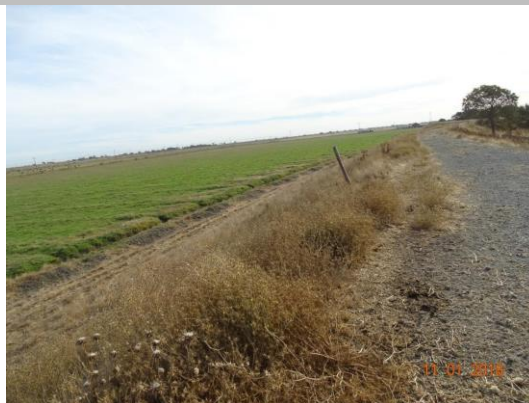
Photo 1 of 1 : SP_2019_RD2104_249_28_20190311_00014.jpg

LM Start	0.95	Rating **	M	Issue No.	28
LM End	1.41	Issue Type +	Ma	Location *	LS
Category	Earthen Levee			GPS Latitude/Longitude	
				Start	End
Item	Vegetation			38.298743 °	38.295683 °
				-121.748813 °	-121.741840 °
DWR ID	DWR_RD2104_01_f_2018_28				
Comment Code					
V1 : Control annual grass and weeds on the levee slopes and easements.					
Inspector Comment

View looking downstream of vegetation on the land side slope (November 2018).

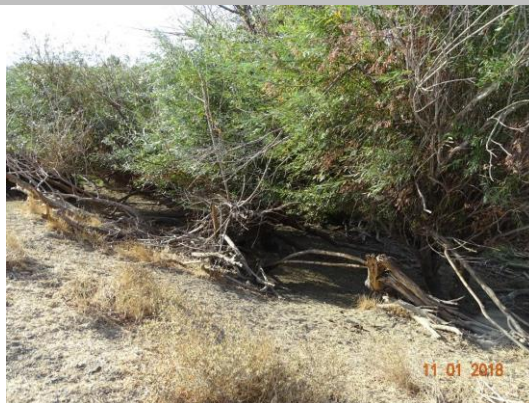
Photo 1 of 1 : SP_2019_RD2104_249_29_20190311_00015.jpg

LM Start	1.26	Rating **	M	Issue No.	29
LM End	1.26	Issue Type +	Ma	Location *	WS
Category	Earthen Levee			GPS Latitude/Longitude	
				Start	End
Item	Encroachments			38.296277 °	38.296277 °
				-121.744393 °	-121.744393 °
DWR ID	DWR_RD2104_01_f_2018_29				
Comment Code					
TR : Tree or limb					
Inspector Comment					
Remove down tree branches on water side slope

View of tree branches on the water side slope (November 2018).

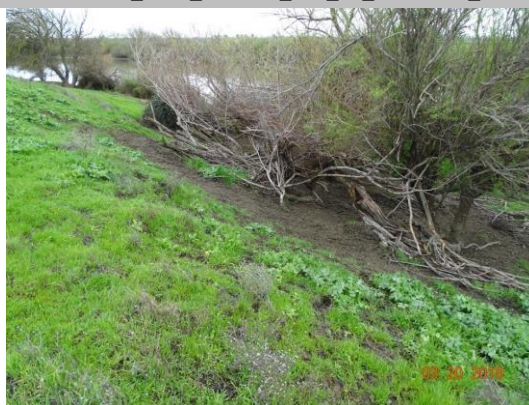
Photo 1 of 1 : SP_2019_RD2104_249_23_20190311_00012.jpg

LM Start	1.27	Rating **	M	Issue No.	23
LM End	1.27	Issue Type +	Ma	Location *	WS
Category	Earthen Levee			GPS Latitude/Longitude	
				Start	End
Item	Slope Stability			38.296182 °	38.296182 °
				-121.744318 °	-121.744318 °
DWR ID	DWR_RD2104_01_f_2016_23				
Comment Code					
S2 : Repair the levee slope damaged by foot traffic and prevent access where possible.					
Inspector Comment					
Repair the slope damaged by cows and trim up the tree limbs partially blocking the erosion site.

Spring 2018 - Trees should be trimmed and deadwood removed, and erosion from cattle repaired.

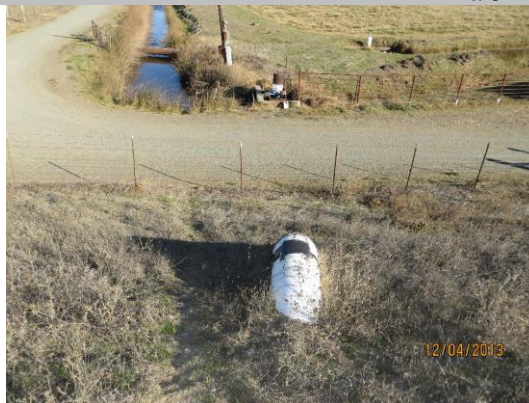
Photo 1 of 3 : UCIP_SP_2019_24984_45042.jpg

Comment Code						
Inspector Comment						
FS_ID:24984 DS_ID:24711 EP_NO: 10185 Repair Type: No Action Needed Crossing Status: Found UCIP Comments: 09/14/2017 Permit is unavailable, missing page 3 official permit documentation. (DWR UCIP - O. Magana) FIELD_STRUCT_DESC: 16-inch steel drainage pipe through the levee, 5.7 feet below the crown. Pump in an irrigation ditch on the landside (LS). Siphon breaker on the waterside (WS) slope. (Automatic Board Order (ABO) issued as Permit No. 10185, 1964 - Erwin E. and Lucy G. Vasser, limited details available electronic permit unavailable). [Additional Reference(s): DWR Levee Log, 2006. USACE Sacramento O&M Manual 108, April 1964, (HLM 1.52), Drawing Nos. 50-04-1977 and 50-04-3379]. FS Date: 12/4/2013

Pipe on LS slope with pump in irrigation ditch off LS toe visible in background.

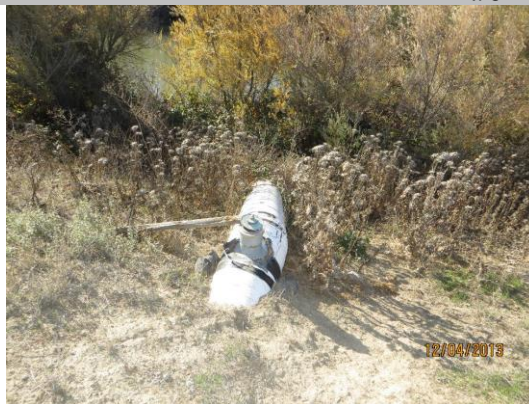
Photo 2 of 3 : UCIP_SP_2019_24984_45041.jpg

Siphon breaker on pipe at WS slope.

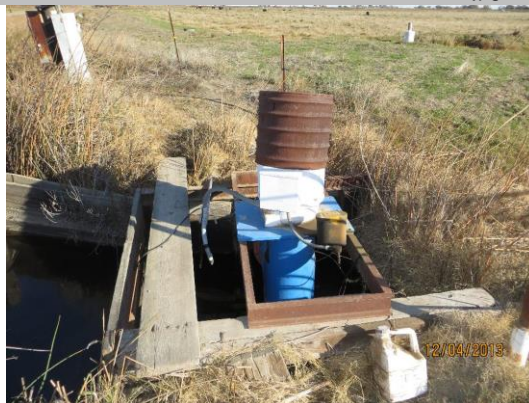
Photo 3 of 3 : UCIP_SP_2019_24984_45040.jpg

Comment Code						
Inspector Comment						
FS_ID:24984 DS_ID:24711 EP_NO: 10185 Repair Type: No Action Needed Crossing Status: Found UCIP Comments: 09/14/2017 Permit is unavailable, missing page 3 official permit documentation. (DWR UCIP - O. Magana) FIELD_STRUCT_DESC: 16-inch steel drainage pipe through the levee, 5.7 feet below the crown. Pump in an irrigation ditch on the landside (LS). Siphon breaker on the waterside (WS) slope. (Automatic Board Order (ABO) issued as Permit No. 10185, 1964 - Erwin E. and Lucy G. Vasser, limited details available electronic permit unavailable). [Additional Reference(s): DWR Levee Log, 2006. USACE Sacramento O&M Manual 108, April 1964, (HLM 1.52), Drawing Nos. 50-04-1977 and 50-04-3379]. FS Date: 12/4/2013

Pump in wooden distribution box off LS toe.

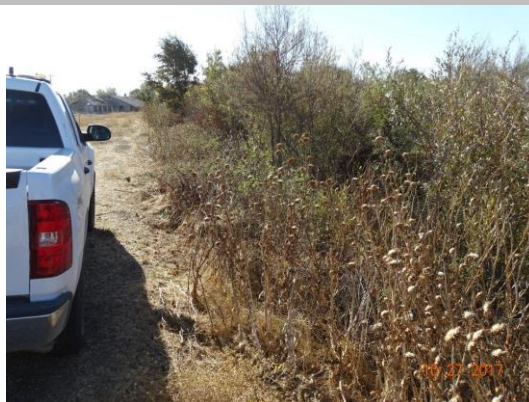
Photo 1 of 1 : SP_2019_RD2104_249_11_20190311_00003.jpg

LM Start	1.44	Rating **	M	Issue No.	11
LM End	1.48	Issue Type +	Ma	Location *	WS
Category	Earthen Levee			GPS Latitude/Longitude	
				Start	End
Item	Vegetation			38.295487 °	38.294947 °
				-121.741530 °	-121.741215 °
DWR ID	DWR_RD2104_01_f_2017_11				
Comment Code					
V2 : Remove the wild growth other than native grasses from the levee slopes.					
Inspector Comment

Remove wild growth to 20 feet from crown.

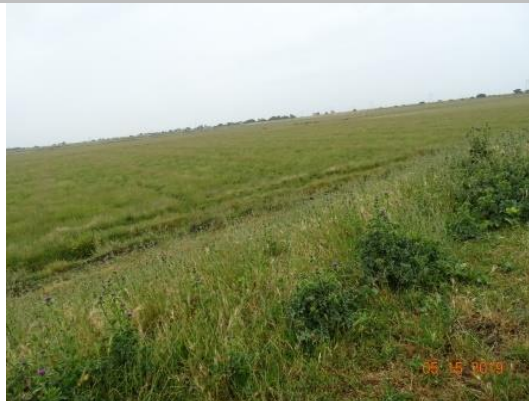
Photo 1 of 1 : SP_2019_RD2104_249_30_20190515_00048.jpg

LM Start	1.54	Rating **	M	Issue No.	30
LM End	4.86	Issue Type +	Ma	Location *	LS
Category	Earthen Levee			GPS Latitude/Longitude	
				Start	End
Item	Vegetation			38.294170 °	38.319363 °
				-121.740883 °	-121.746788 °
DWR ID	DWR_RD2104_01_f_2018_30				
Comment Code					
V1 : Control annual grass and weeds on the levee slopes and easements.					
Inspector Comment

View looking downstream at annual vegetation on the landside slope (Spring 2019).

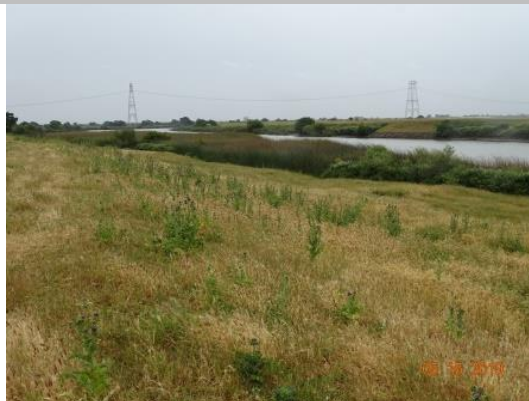
Photo 1 of 1 : SP_2019_RD2104_249_46_20190515_00049.jpg

LM Start	1.60	Rating **	M	Issue No.	46
LM End	4.86	Issue Type +	Ma	Location *	WS
Category	Earthen Levee			GPS Latitude/Longitude	
				Start	End
Item	Vegetation			38.293993 °	38.319363 °
				-121.739832 °	-121.746788 °
DWR ID	DWR_RD2104_01_s_2019_46				
Comment Code					
V1 : Control annual grass and weeds on the levee slopes and easements.					
Inspector Comment

View looking downstream at annual vegetation on the waterside slope (Spring 2019).

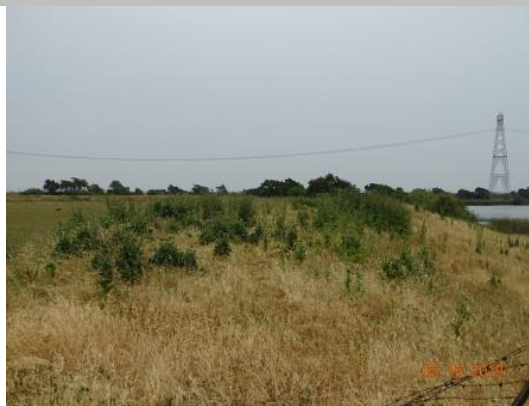
Photo 1 of 1 : SP_2019_RD2104_249_47_20190515_00050.jpg

LM Start	2.10	Rating **	U	Issue No.	47
LM End	2.39	Issue Type +	Ma	Location *	CR
Category	Earthen Levee			GPS Latitude/Longitude	
				Start	End
Item	Vegetation			38.292052 °	38.291605 °
				-121.731543 °	-121.726282 °
DWR ID	DWR_RD2104_01_s_2019_47				
Comment Code					
V9 : Keep the crown roadway free of vegetation.					
Inspector Comment					
Remove thick vegetation from the crown

View looking downstream at thick vegetation on the crown (Spring 2019).

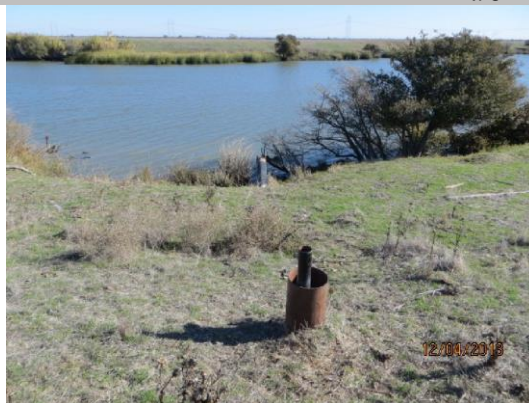
Photo 1 of 2 : UCIP_SP_2019_24990_45047.jpg

Comment Code						
Inspector Comment						
FS_ID:24990 DS_ID:24708 EP_NO: 10185 Repair Type: No Action Needed Crossing Status: Found UCIP Comments: 09/14/2017 Permit is unavailable, missing page 3 official permit documentation. (DWR UCIP - O. Magana) FIELD_STRUCT_DESC: 12-inch steel drainage pipe through the levee 4 feet below the crown. Pump on pile structure in drainage canal on the landside (LS). Siphon breaker in a 12-inch steel riser on the waterside (WS) slope. (Automatic Board Order (ABO) issued as Permit No. 10185, 1964 - Erwin E. and Lucy G. Vassar, limited information available electronic version of permit missing. Replaced under Permit No. 4412, 1963 - Ervin E. and Lucy G. Vassar, limited details available electronic permit copy unavailable). [Additional Reference(s): DWR Levee Log, 2006. USACE Sacramento O&M Manual 108, April 1964, (HLM 3.12), Drawing No. 50-04-3379]. FS Date: 12/4/2013

Siphon breaker in steel riser on WS slope with pipe and flap gate visible in background at WS berm.

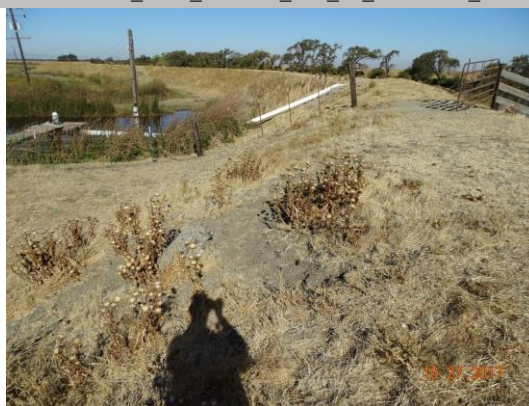
Photo 1 of 1 : SP_2019_RD2104_249_21_20190311_00010.jpg

LM Start	4.00	Rating **	M	Issue No.	21
LM End	4.00	Issue Type +	Ma	Location *	LS
Category	Earthen Levee			GPS Latitude/Longitude	
				Start	End
Item	Slope Stability			38.310672 °	38.310672 °
				-121.736155 °	-121.736155 °
DWR ID	DWR_RD2104_01_f_2018_21				
Comment Code					
S2 : Repair the levee slope damaged by foot traffic and prevent access where possible.					
Inspector Comment

Repair landside slope eroded by livestock, and prevent future erosion.

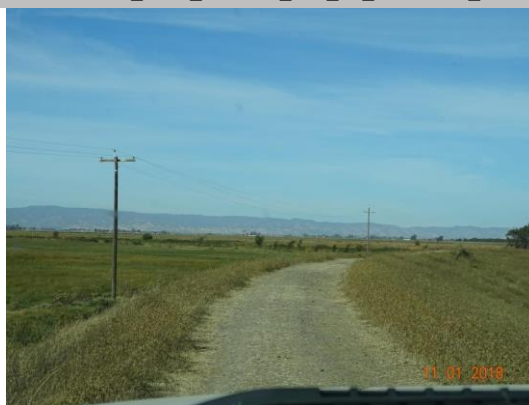
Photo 1 of 2 : SP_2019_RD2104_249_17_20190311_00007.jpg

LM Start	4.05	Rating **	M	Issue No.	17
LM End	4.30	Issue Type +	Ma	Location *	WS
Category	Earthen Levee			GPS Latitude/Longitude	
				Start	End
Item	Vegetation			38.311335 °	38.313822 °
				-121.736643 °	-121.739757 °
DWR ID	DWR_RD2104_01_s_2018_17				
Comment Code					
V2 : Remove the wild growth other than native grasses from the levee slopes.					
Inspector Comment

View looking upstream at vegetation on the water side slope (November 2018).

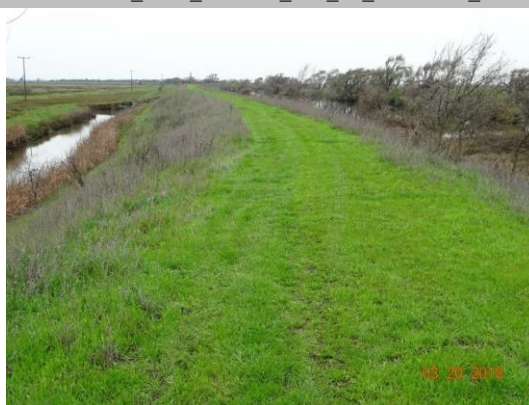
Photo 2 of 2 : SP_2019_RD2104_249_17_20190311_00008.jpg

Waterside (right) vegetation should be managed to 20 feet from crown to allow inspection and access.

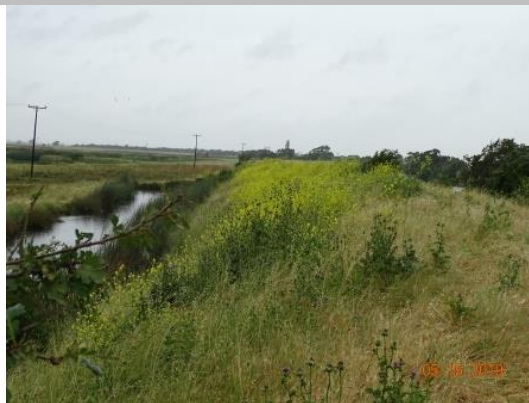
Photo 1 of 1 : SP_2019_RD2104_249_10_20190515_00051.jpg

LM Start	4.25	Rating **	U	Issue No.	10
LM End	4.30	Issue Type +	Ma	Location *	LS
Category	Earthen Levee			GPS Latitude/Longitude	
				Start	End
Item	Vegetation			38.313253 °	38.313822 °
				-121.739152 °	-121.739757 °
DWR ID	DWR_RD2104_01_s_2018_10				
Comment Code					
V2 : Remove the wild growth other than native grasses from the levee slopes.					
Inspector Comment

View looking upstream at wildgrowth on the landside slope (Spring 2019).

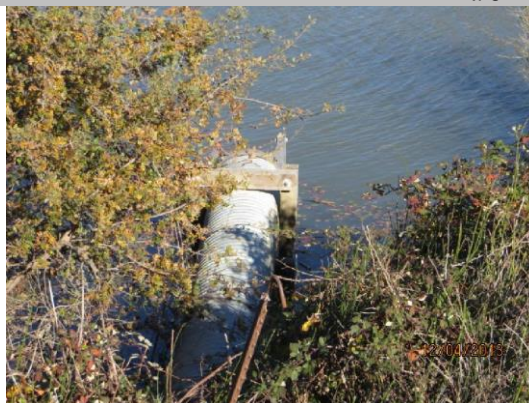
Photo 1 of 3 : UCIP_SP_2019_51459_45062.jpg

Comment Code						
Inspector Comment						
FS_ID:51459 DS_ID:24705 EP_NO: 10182 Repair Type: Non-Urgent Crossing Status: Found UCIP Comments: 12/06/2016 Crossing has been downgraded from "Urgent" to "Non-Urgent" no signs of leaks observed along pipe alignment (limited inspection on WS toe). According to LMA representative, this crossing was replaced 6 years ago (2010) at WS concrete apron. Recommend conducting internal inspection of pipe through the levee and LS to determine pipe integrity. (O. Magana - DWR UCIP)12/04/2013 Vegetation and soil buildup throughout pipe preventing flapgate from closing. Remove vegetation to allow gate to close properly. (W. Wylie - DWR UCIP) FIELD_STRUCT_DESC: 24-inch corrugated metal drainage pipe through the levee, 15 feet below the crown. 36-inch concrete standpipe on the landside (LS) toe. Flap gate on the waterside (WS) toe. Two corrugated metal cutoff walls installed. (24-inch pipe [HLM 4.65] authorized under Automatic Board Order (ABO) issued as Permit No. 10182, 1974 - Julia Trust Machado). [Additional Reference(s): DWR Levee Log, 2006. USACE Sacramento O&M Manual 108, April 1964, (HLM 4.65), Drawing No. 50-04-3379]. FS Date: 12/6/2016

CMP pipe and flapgate off WS toe.

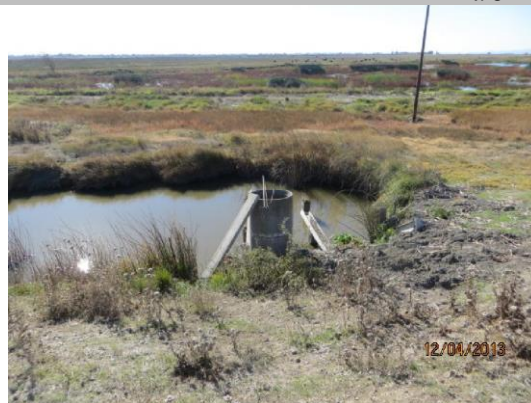
Photo 2 of 3 : UCIP_SP_2019_51459_45061.jpg

Comment Code						
Inspector Comment						
FS_ID:51459 DS_ID:24705 EP_NO: 10182 Repair Type: Non-Urgent Crossing Status: Found UCIP Comments: 12/06/2016 Crossing has been downgraded from "Urgent" to "Non-Urgent" no signs of leaks observed along pipe alignment (limited inspection on WS toe). According to LMA representative, this crossing was replaced 6 years ago (2010) at WS concrete apron. Recommend conducting internal inspection of pipe through the levee and LS to determine pipe integrity. (O. Magana - DWR UCIP)12/04/2013 Vegetation and soil buildup throughout pipe preventing flapgate from closing. Remove vegetation to allow gate to close properly. (W. Wylie - DWR UCIP) FIELD_STRUCT_DESC: 24-inch corrugated metal drainage pipe through the levee, 15 feet below the crown. 36-inch concrete standpipe on the landside (LS) toe. Flap gate on the waterside (WS) toe. Two corrugated metal cutoff walls installed. (24-inch pipe [HLM 4.65] authorized under Automatic Board Order (ABO) issued as Permit No. 10182, 1974 - Julia Trust Machado). [Additional Reference(s): DWR Levee Log, 2006. USACE Sacramento O&M Manual 108, April 1964, (HLM 4.65), Drawing No. 50-04-3379]. FS Date: 12/6/2016

36-inch concrete riser on LS toe at channel.

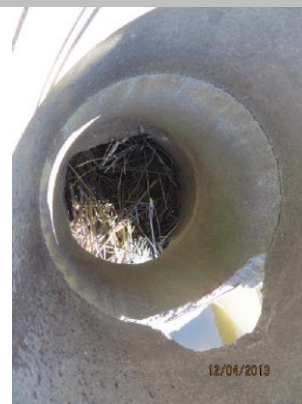
Photo 3 of 3 : UCIP_SP_2019_51459_45060.jpg

36-inch concrete riser with vegetation buildup inside.

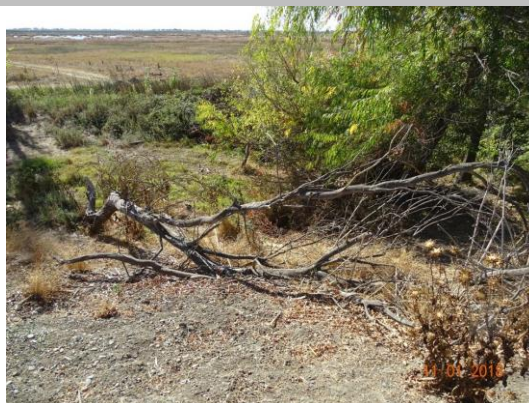
Photo 1 of 1 : SP_2019_RD2104_249_31_20190311_00016.jpg

LM Start	4.71	Rating **	M	Issue No.	31
LM End	4.71	Issue Type +	Ma	Location *	LS
Category	Earthen Levee			GPS Latitude/Longitude	
				Start	End
Item	Encroachments			38.318407 °	38.318407 °
				-121.744495 °	-121.744495 °
DWR ID	DWR_RD2104_01_f_2018_31				
Comment Code					
TR : Tree or limb					
Inspector Comment					
Remove tree limb on landside slope

View of down tree limb on the land side slope (November 2018).

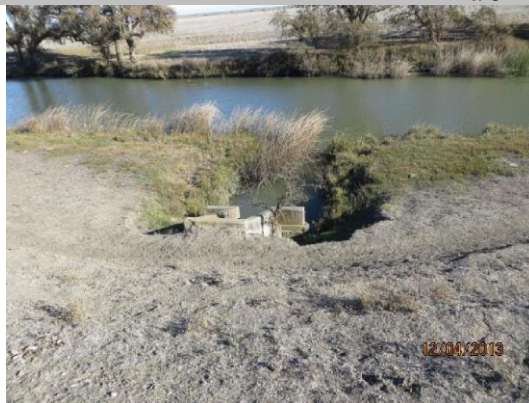
Photo 1 of 3 : UCIP_SP_2019_53387_45090.jpg

Comment Code						
Inspector Comment						
FS_ID:53387 DS_ID:24701 EP_NO: 10182 Repair Type: Urgent Crossing Status: Found UCIP Comments: 10/12/2018 Same as last inspection; concrete headwall on WS still being undermined so crossing remains Urgent (D. Sanoski - DWR UCIP).12/06/2016 same as last inspection--pipe remains "Urgent" CMP shows holes through wall and concrete headwall is undermined. Need to contact owner. Owner will need to work with the CVFPB to comply with Title 23. (O. Magana - DWR UCIP)12/04/2013 Footing under headwall on WS toe severely undermined. Pipe rusted heavily with holes at WS and may need replacement. (W. Wylie - DWR UCIP) FIELD_STRUCT_DESC: 24-inch corrugated metal drainage pipe through the levee, 13 feet below the crown. Two cutoff walls. Concrete U-shaped headwalls on both ends. Flap gate on the waterside (WS). (24-inch pipe [HLM 5.50] authorized under Automatic Board Order (ABO) issued as Permit No. 10182, 1974 - Julia Trust Machado). [Additional Reference(s): DWR Levee Log, 2006. USACE Sacramento O&M Manual 108, April 1964, (HLM 5.5), listed as a 12-inch pipe, Drawing No. 50-04-3379, listed as an 18-inch pipe]. FS Date: 10/12/2018 5:06:00 PM

Concrete U-shaped headwall on WS toe. Note erosion scarp around headwall.

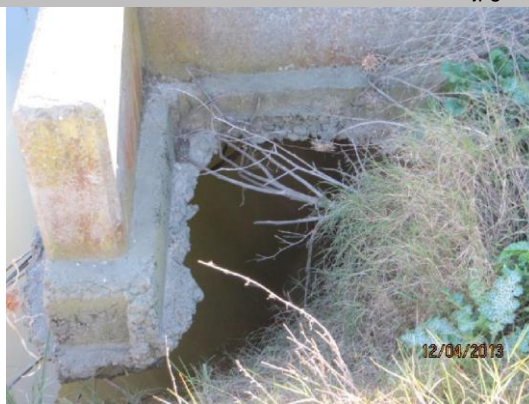
Photo 2 of 3 : UCIP_SP_2019_53387_45089.jpg

Headwall undermined on WS toe.

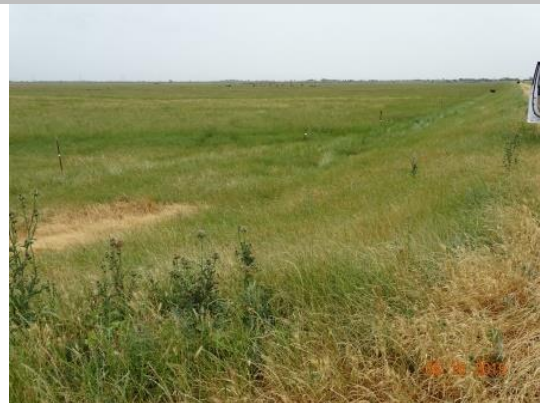
Photo 1 of 1 : SP_2019_RD2104_249_39_20190515_00046.jpg

LM Start	5.16	Rating **	M	Issue No.	39
LM End	6.84	Issue Type +	Ma	Location *	LS
Category	Earthen Levee			GPS Latitude/Longitude	
				Start	End
Item	Vegetation			38.323058 °	38.308411 °
				-121.748987 °	-121.758545 °
DWR ID	DWR_RD2104_01_s_2019_39				
Comment Code					
V1 : Control annual grass and weeds on the levee slopes and easements.					
Inspector Comment					
Maintain annual vegetation on the landside slope

View looking downstream at annual vegetation on the landside slope (Spring 2019).

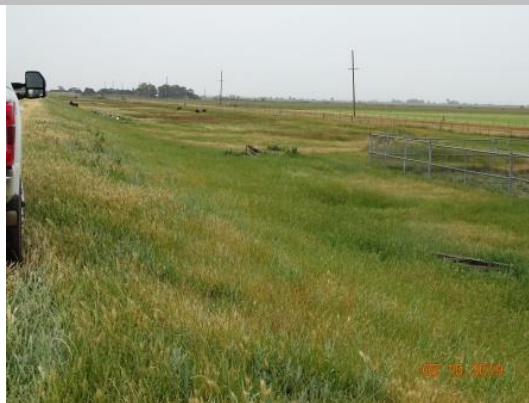
Photo 1 of 2 : SP_2019_RD2104_249_43_20190515_00047.jpg

View looking downstream at annual vegetation on the waterside slope (Spring 2019).

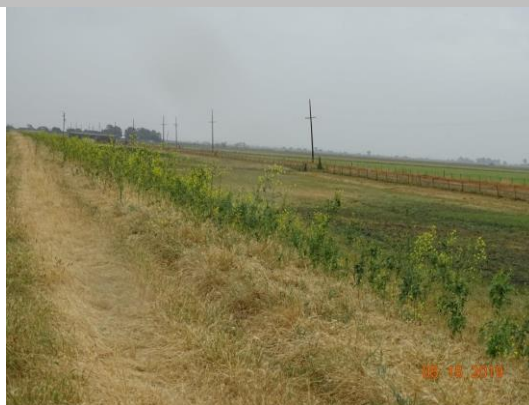
Photo 2 of 2 : SP_2019_RD2104_249_43_20190520_00054.jpg

View looking downstream at annual vegetation on the waterside slope (Spring 2019).
